# ULTRAVIOLET DISINFECTION FOR STORMWATER TREATMENT IN COASTAL CAROLINAS

Ronald A. Geiger HDR Engineering, Charlotte, NC  
Tom Garigen, Horry County Storm Water, Conway, SC

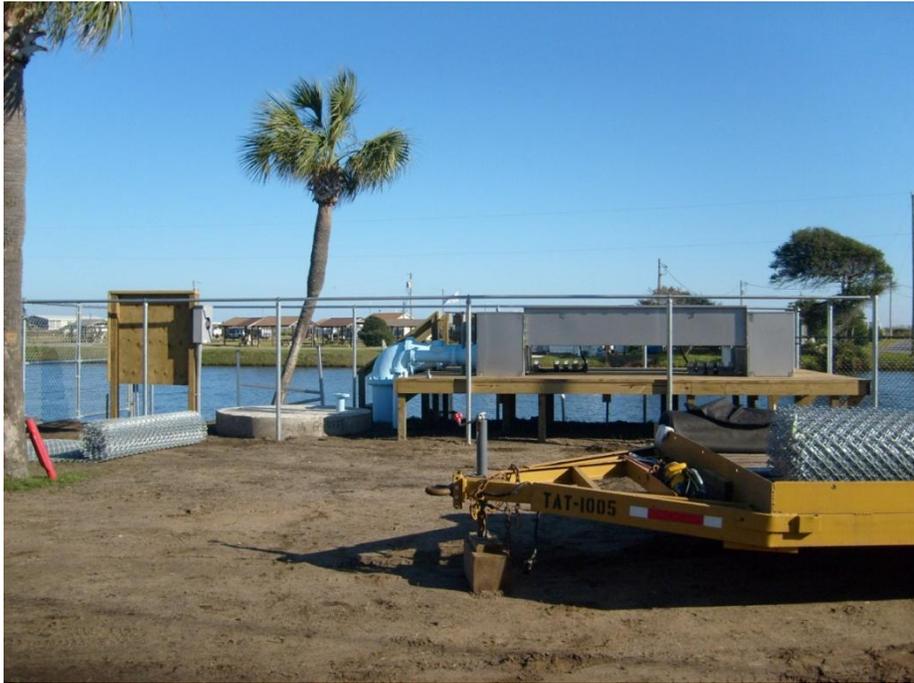
Figure 4 – Side View of UV Units prior to fence enclosure

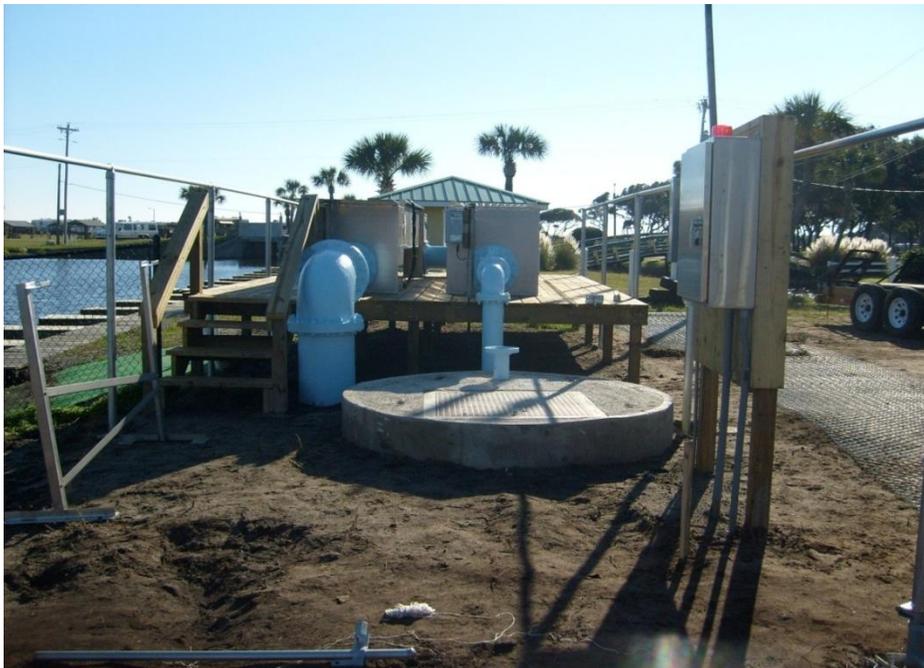
Figure 5 – End View of UV unit showing intake and outlet piping, and pump station
